# **Numurkah Floodplain Management Study and Plan Study Report**

**November 2017**

| Report Number | R03 v09 |

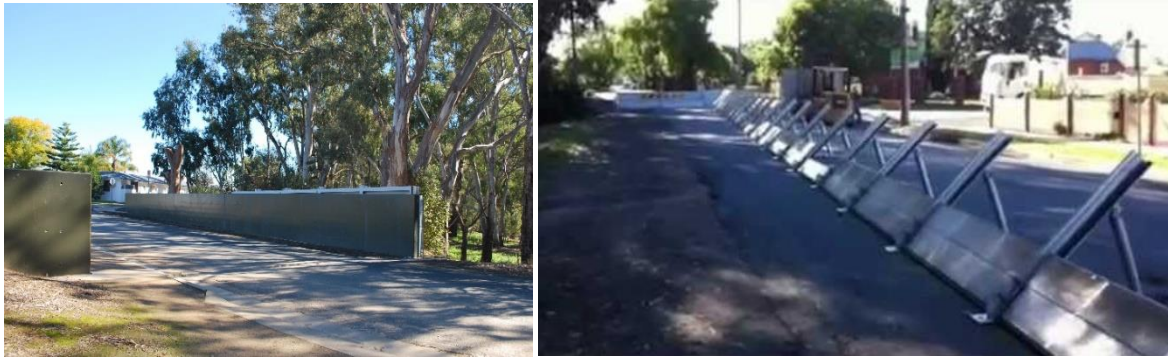
**Figure 12-27** Examples of temporary flood gates and demountable walls in Deniliquin, NSW and Nathalia, VIC

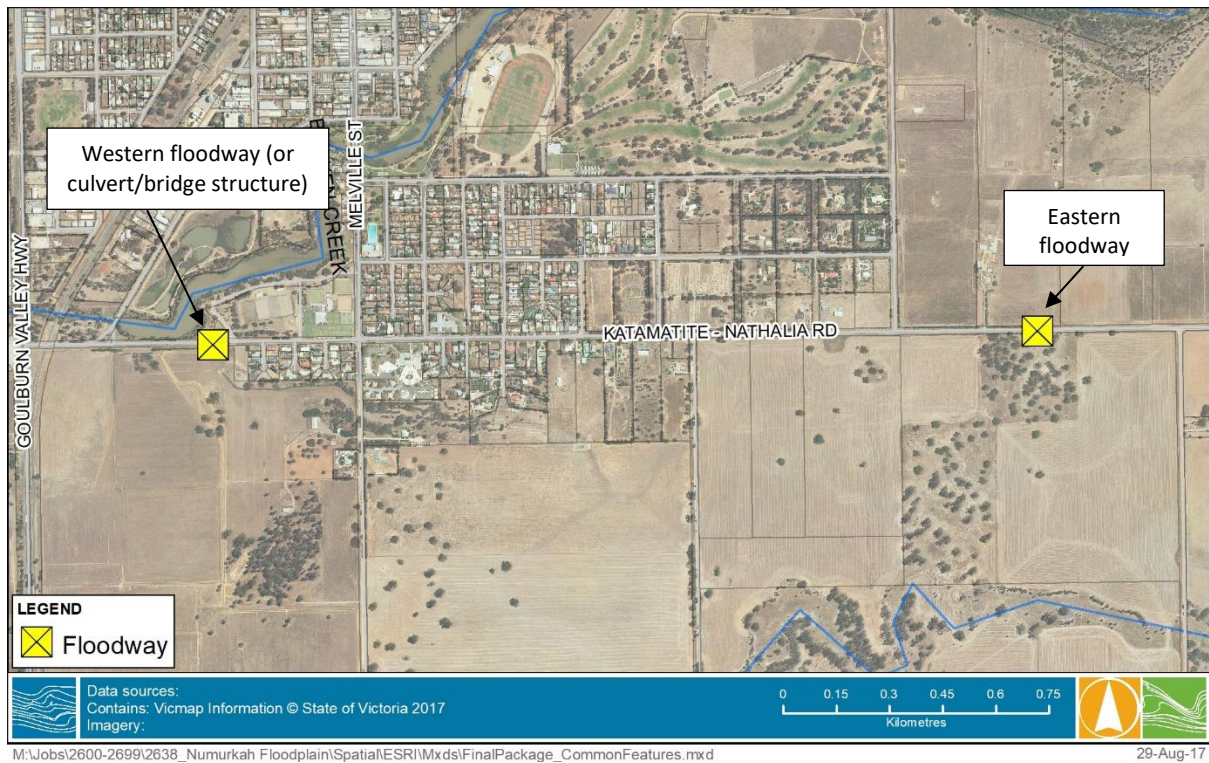
**Figure 12-29** Location of Katamatite-Nathalia Road floodways
