# Moira Shire Flood Emergency Plan

A Sub-Plan of the Municipal  
Emergency Management Plan

For Moira Shire Council  
And  
VICSES  
North East Region and the  
Cobram, Numurkah and Yarrawonga Units  
September 2020 Version 1.1

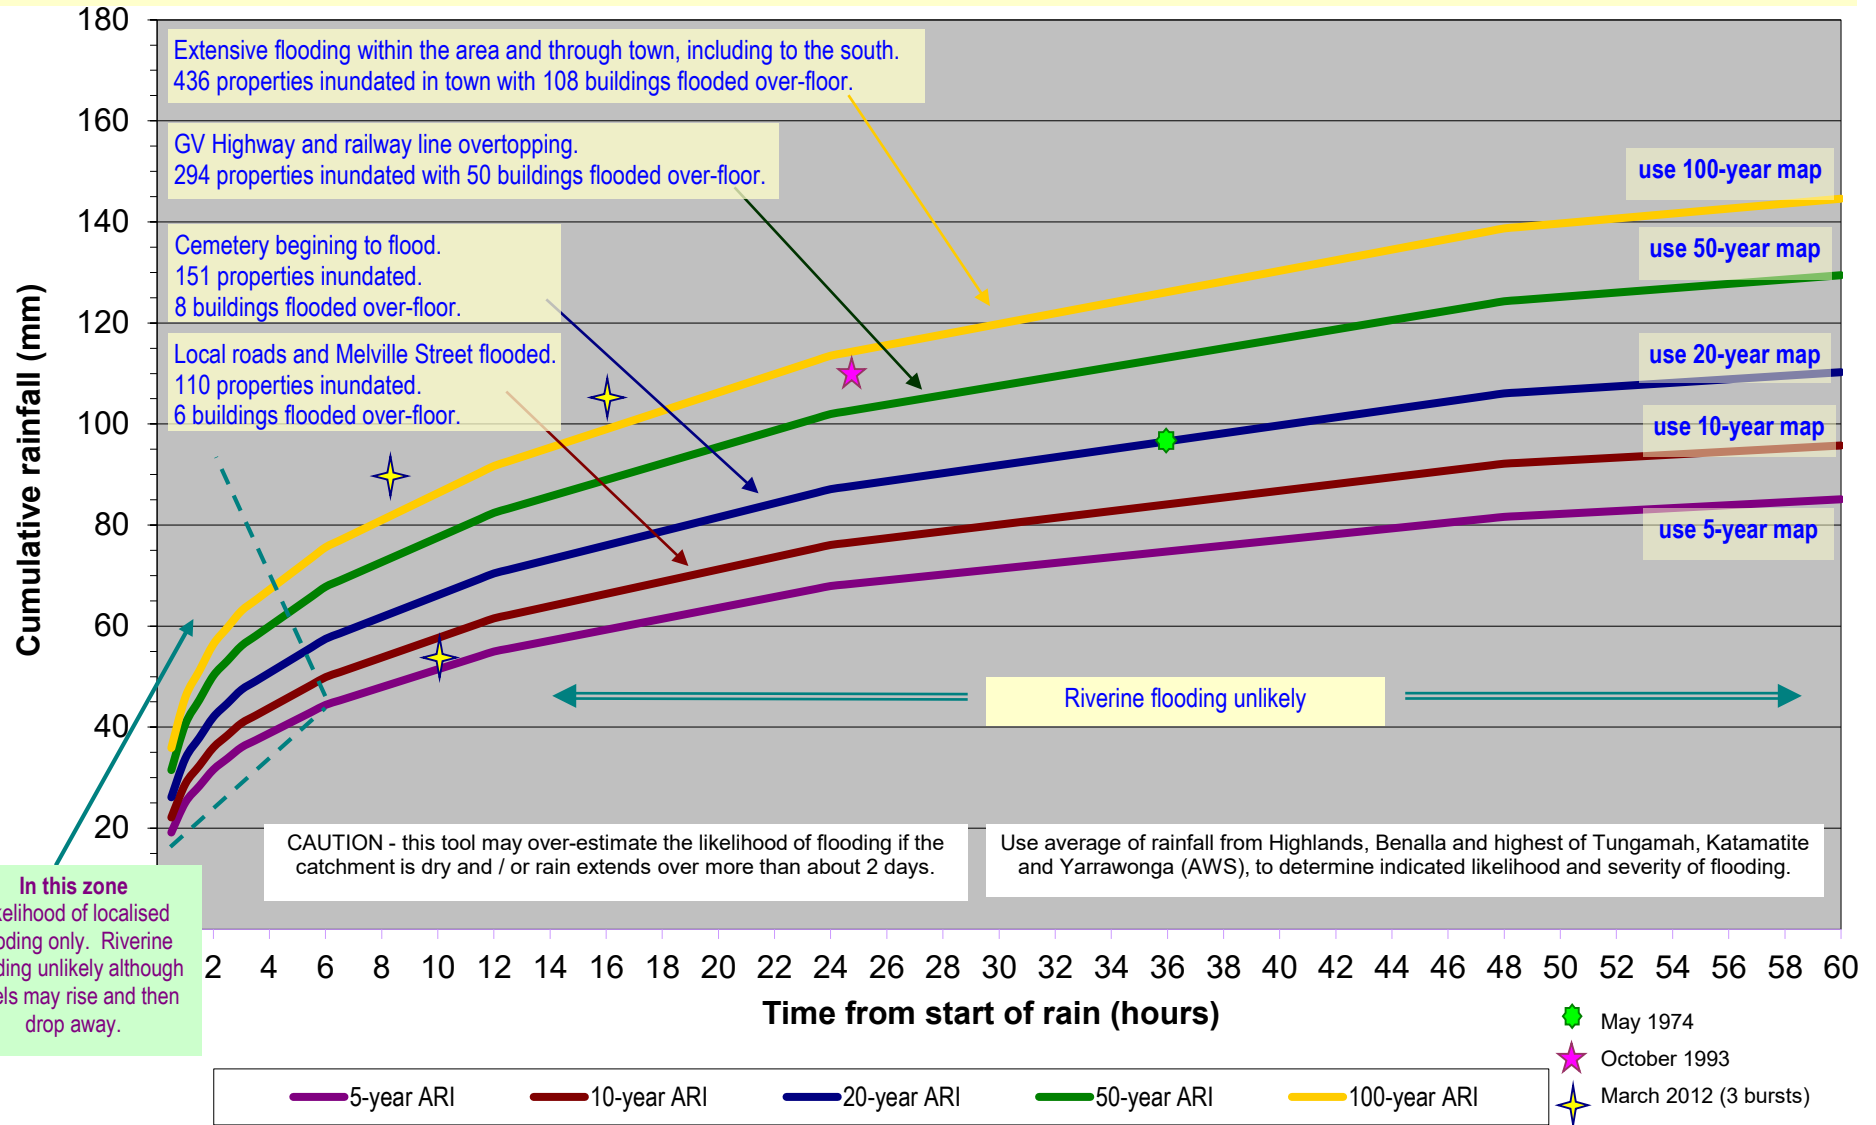
This guide assumes that rainfall affects the whole catchment and is not localised heavy falls. If localised, the guide may over-estimate the likelihood of flooding. If the catchment is very wet, move up one level. For example, if rainfall is on the 10-year curve and the catchment is very wet, refer to the 20-year map and consequences.

**Approximate severity of flooding at Numurkah from upstream levels for whole of catchment rain event**

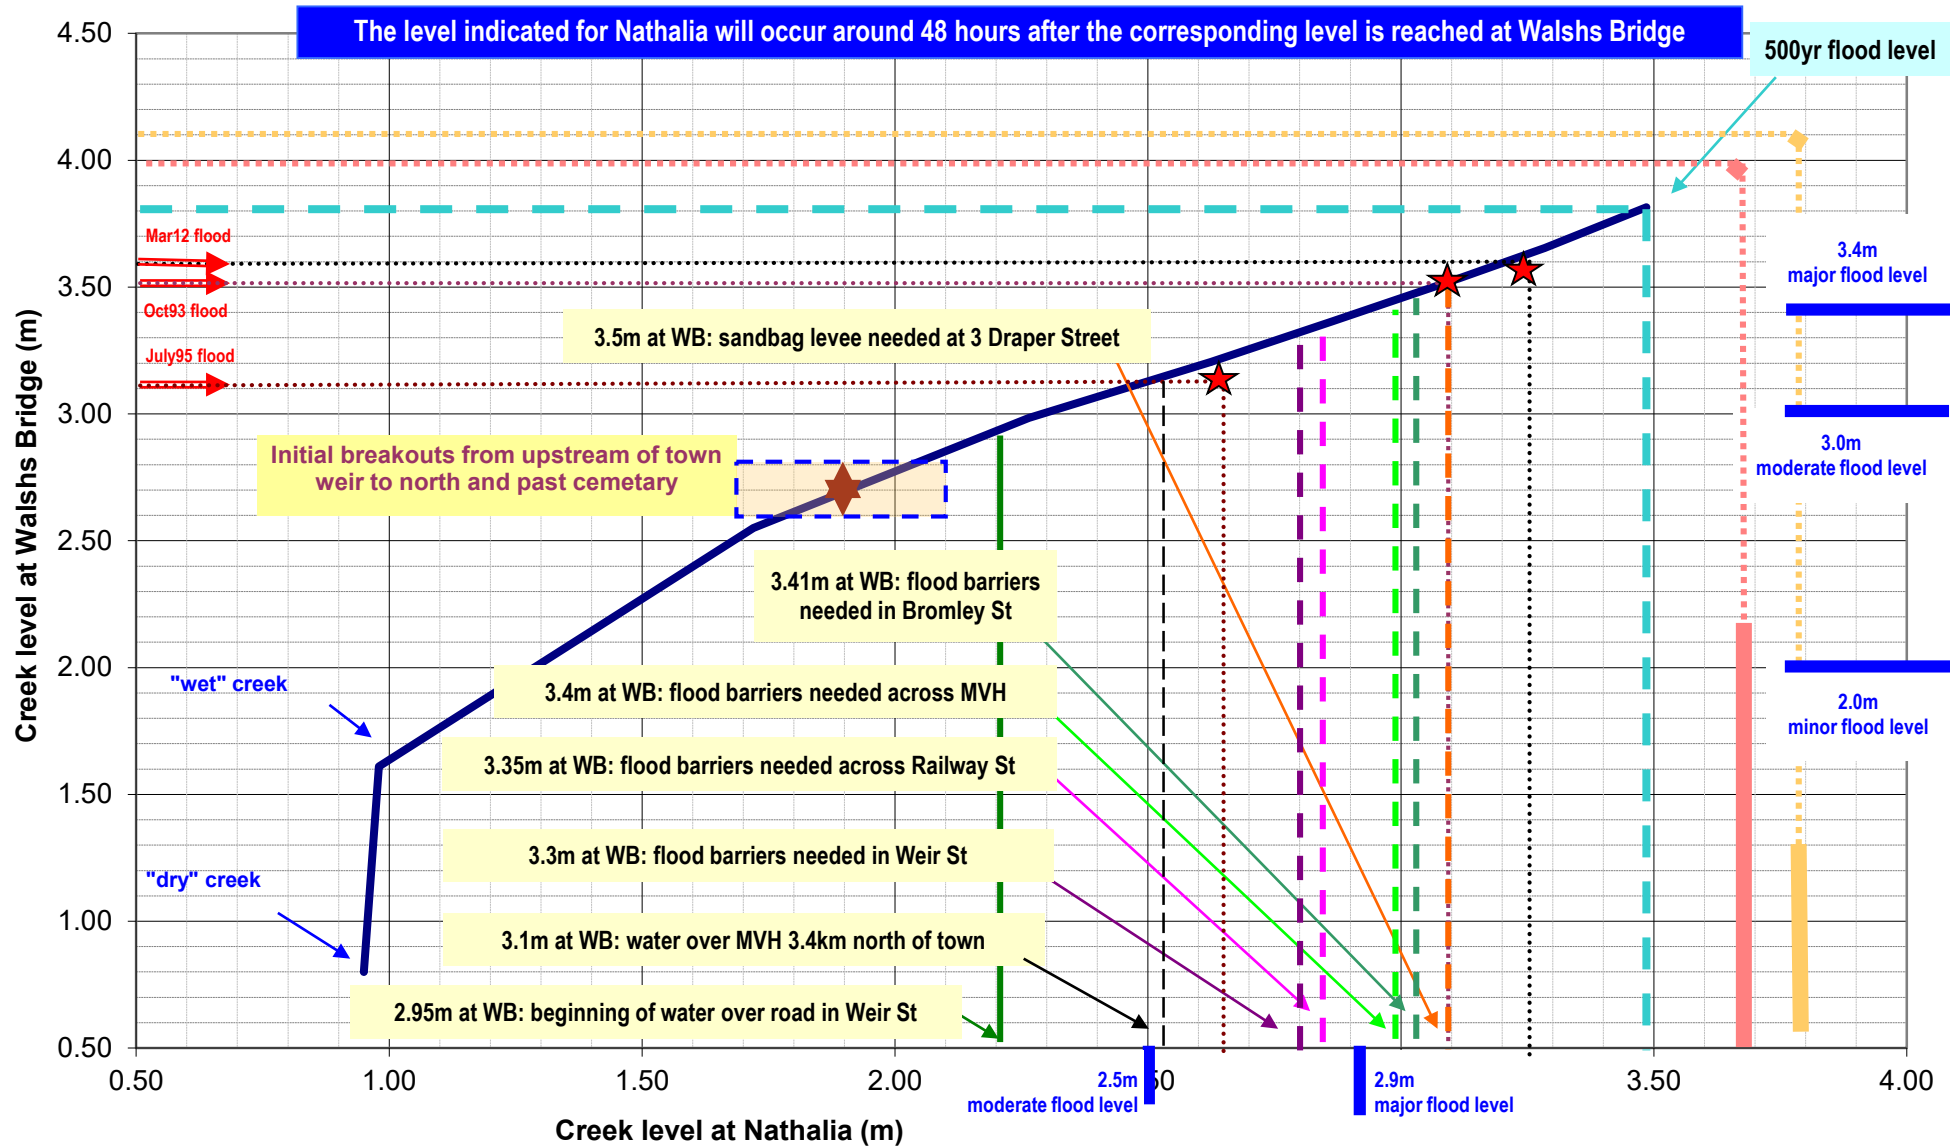
Note that all levels on this diagram have been corrected to be consistent with current gauge plates at Walshs Bridge and Nathalia

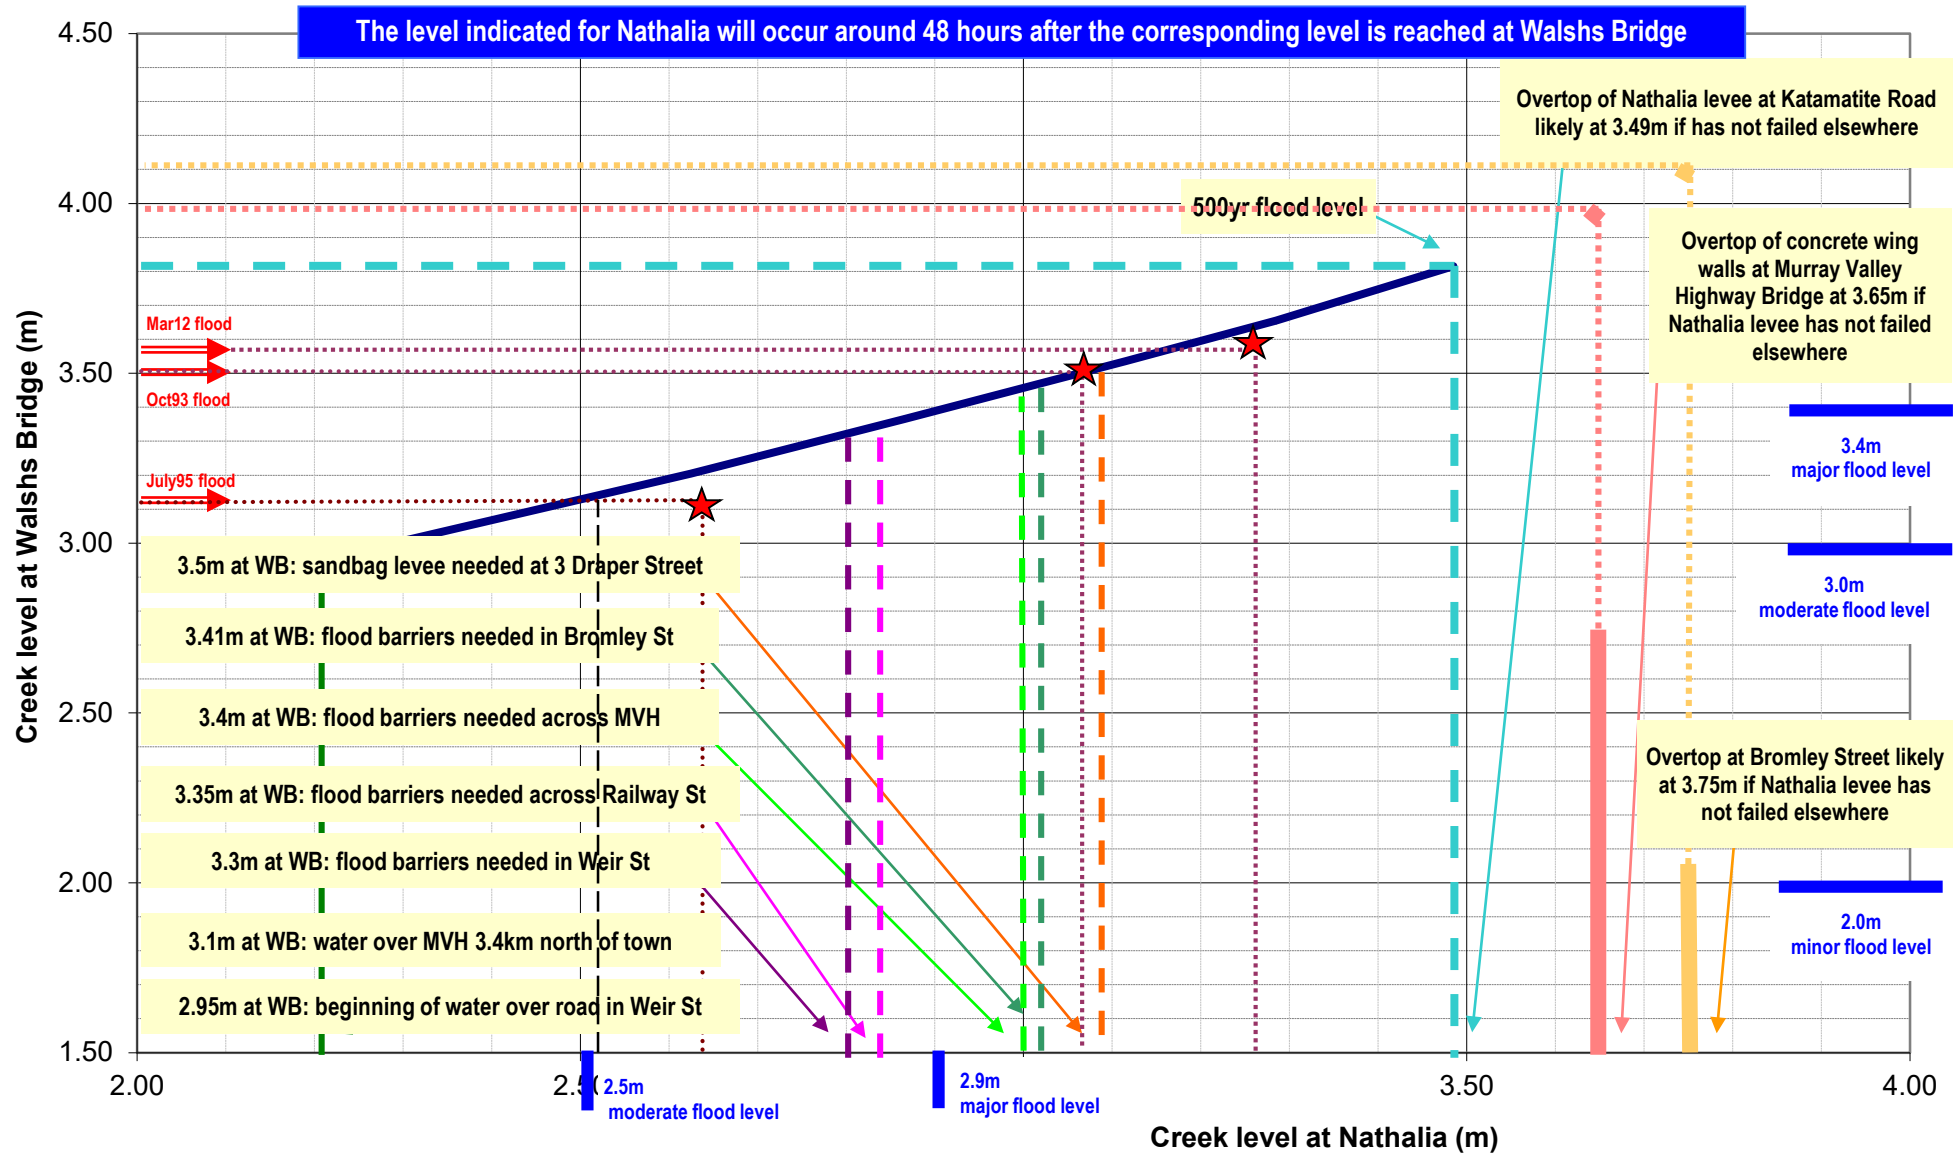
Note that all levels on this diagram have been corrected to be consistent with current gauge plates at Walshs Bridge and Nathalia
