ELECTRIC LINE CLEARANCE MANAGEMENT PLAN

2023 – 2024

In accordance with Electric Line Clearance Regulations 2020

Document name: Electric Line Clearance Management Plan 2023/24
Prepared by: Moira Shire Council
Internal document number: D23/026552
Record management folder number: F13/864

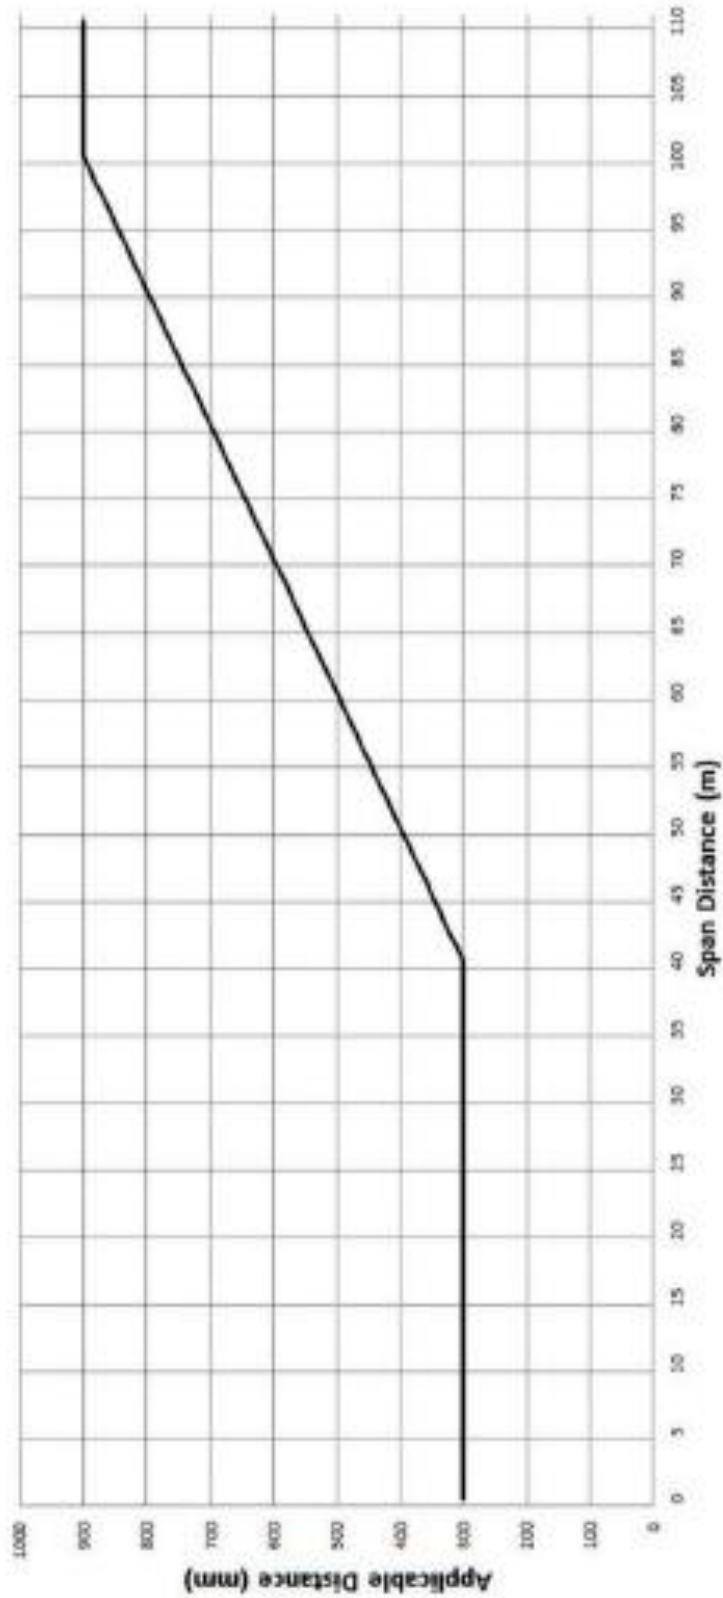
GRAPH 1—INSULATED ELECTRIC LINES IN ALL AREAS

Clauses 3 and 24

Graph 1 Formula

The formula by which the applicable distance for the middle two thirds of a span of an electric line to which clause 24 applies is calculated is as follows:

To determine additional distance that allows for cable sag and sway for the purposes of determining a minimum clearance space in accordance with Division 1 of Part 3 of the Code, Council's Arborist team use their experience, knowledge and understanding of the environment and the condition of the trees through their annual inspections and ongoing maintenance of the street trees. Reference is also made to the graphs in Schedule 2 of the Code which are attached as *Appendix 7*.

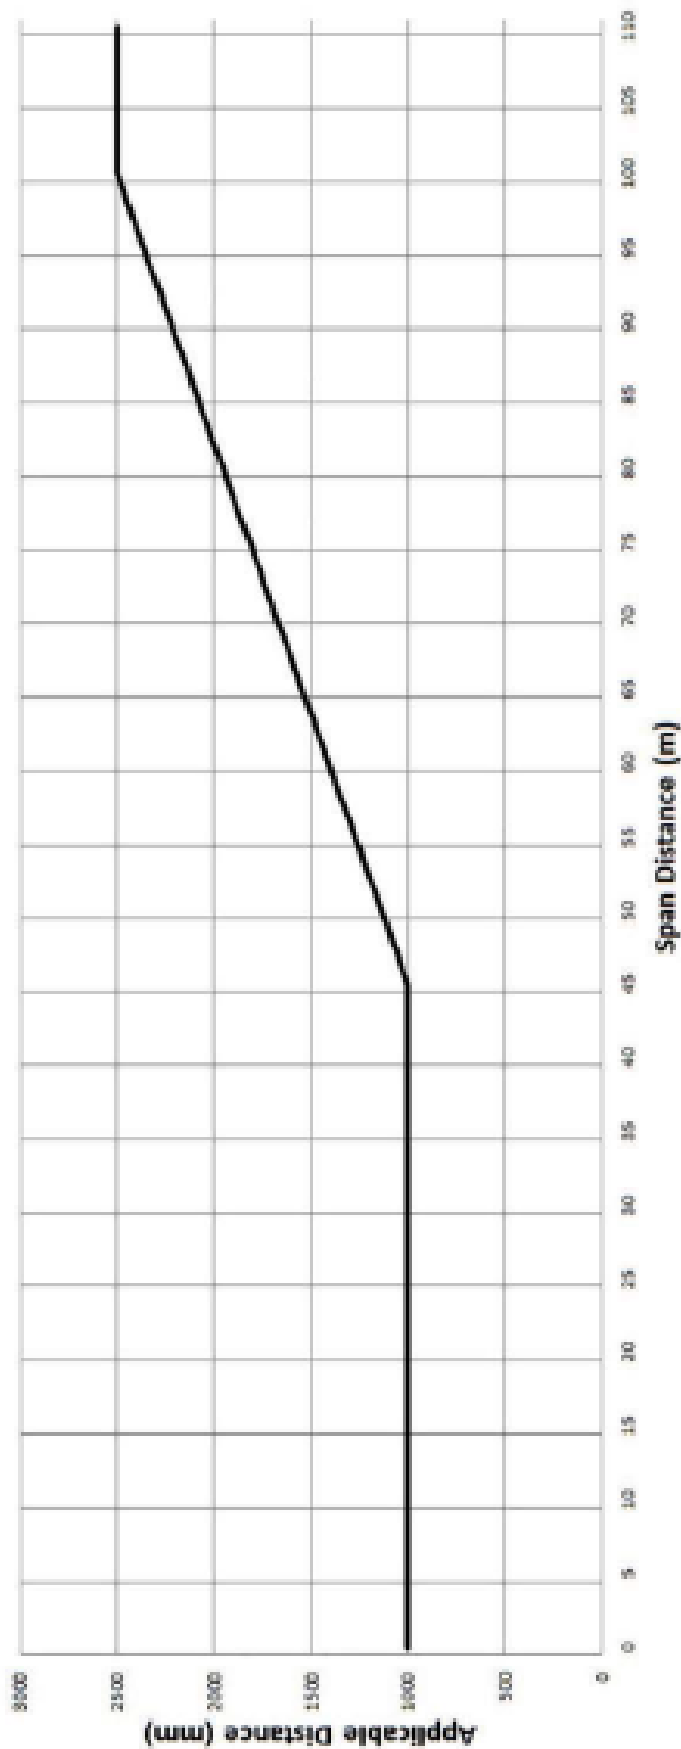
GRAPH 2—UNINSULATED LOW VOLTAGE ELECTRIC LINE IN LOW BUSHFIRE RISK AREA

Clauses 3 and 25

Graph 2 Formula

The formula by which the applicable distance for the middle two thirds of a span of an electric line to which clause 25 applies is calculated is as follows:

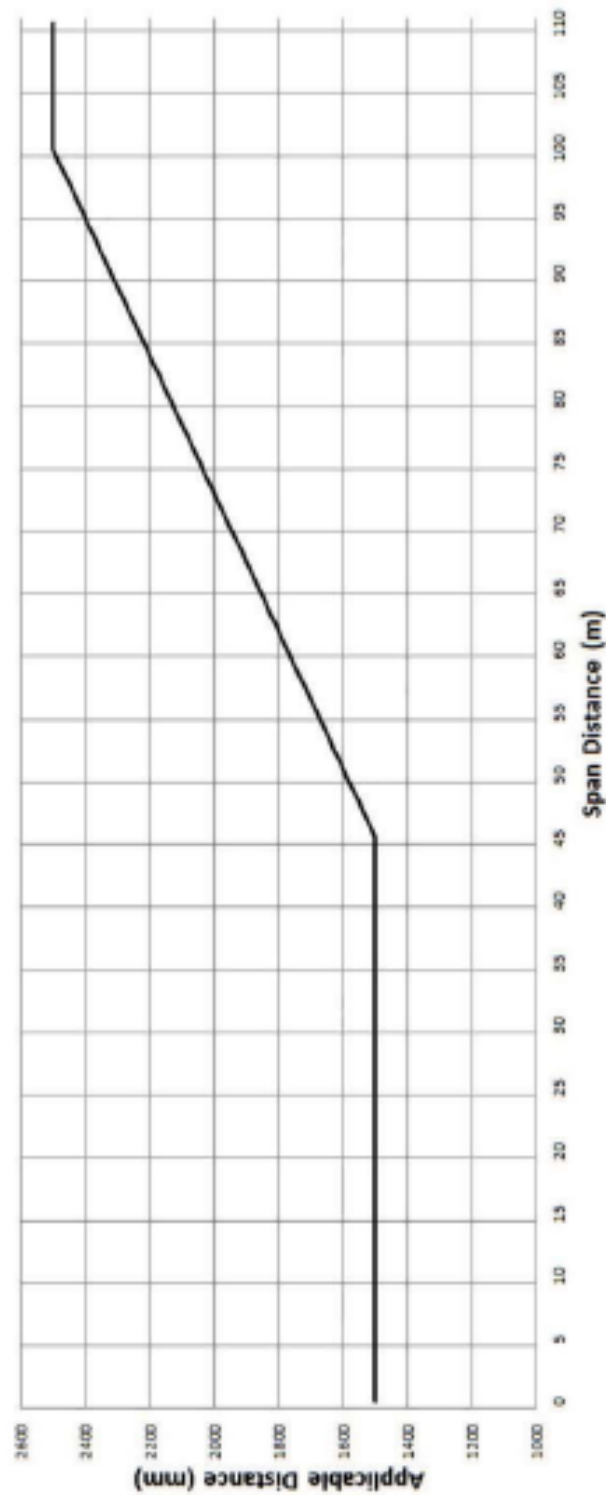
GRAPH 3—UNINSULATED HIGH VOLTAGE ELECTRIC LINE (OTHER THAN A 66 000 VOLT ELECTRIC LINE) IN LOW BUSHFIRE RISK AREA

Clauses 3 and 26

Graph 3 Formula

The formula by which the applicable distance for the middle two thirds of a span of an electric line to which clause 26 applies is calculated is as follows:

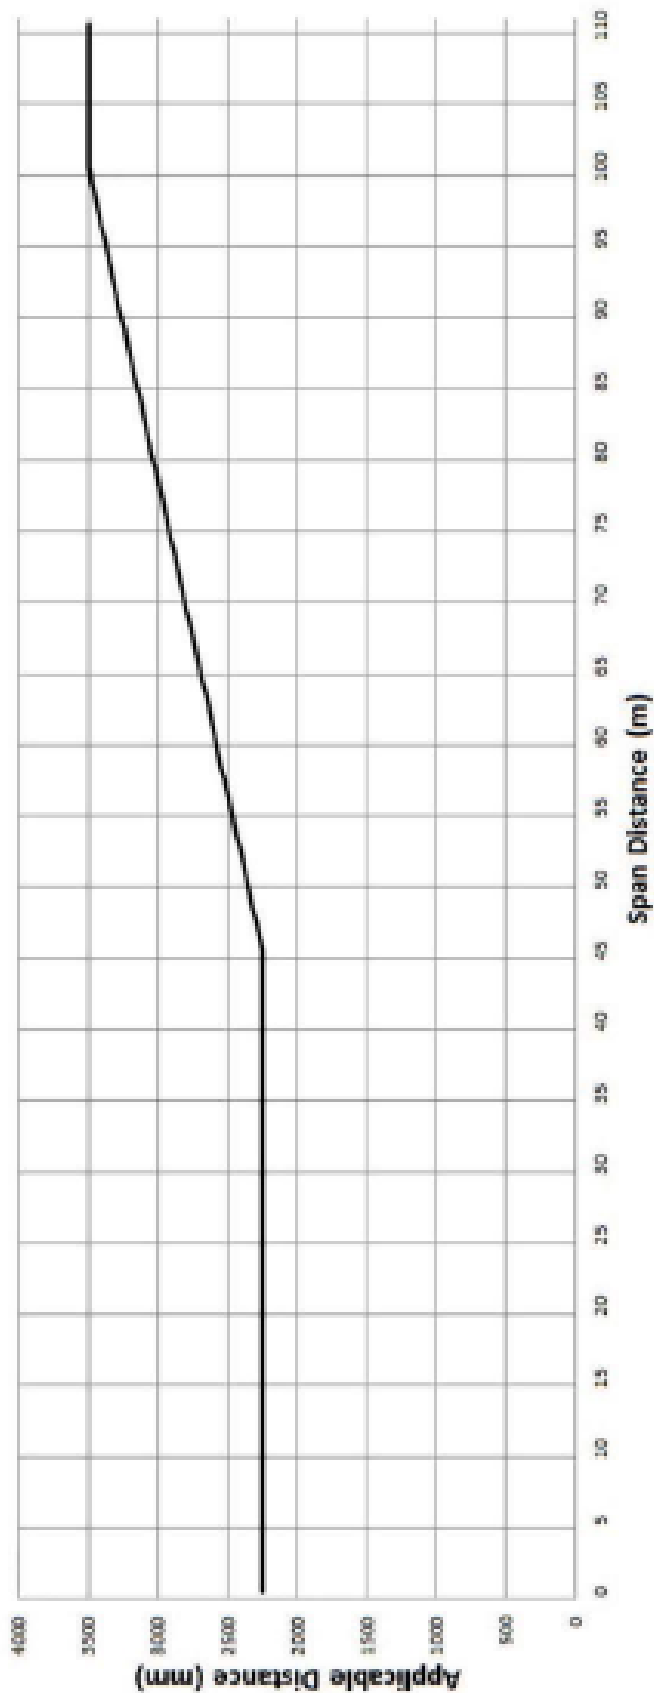
GRAPH 4—UNINSULATED 66 000 VOLT ELECTRIC LINE IN LOW BUSHFIRE RISK AREA

Clauses 3 and 27

Graph 4 Formula

The formula by which the applicable distance for the middle two thirds of a span of an electric line to which clause 27 applies is calculated is as follows:

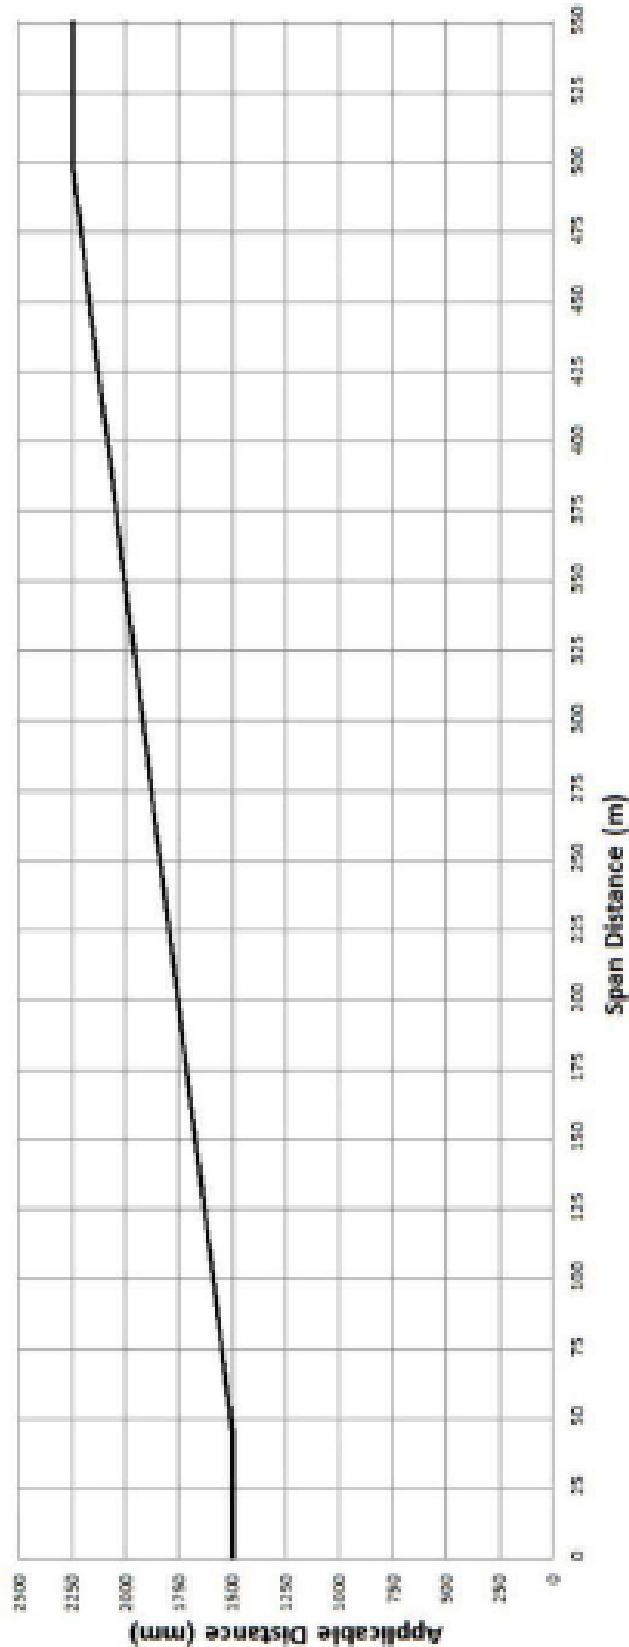
GRAPH 5—UNINSULATED LOW VOLTAGE AND HIGH VOLTAGE ELECTRIC LINE (OTHER THAN A 66 000 VOLT ELECTRIC LINE) IN HAZARDOUS BUSHFIRE RISK AREA

Clauses 3 and 28

Graph 5 Formula

The formula by which the applicable distance for the middle two thirds of a span of an electric line to which clause 28 applies is calculated is as follows:

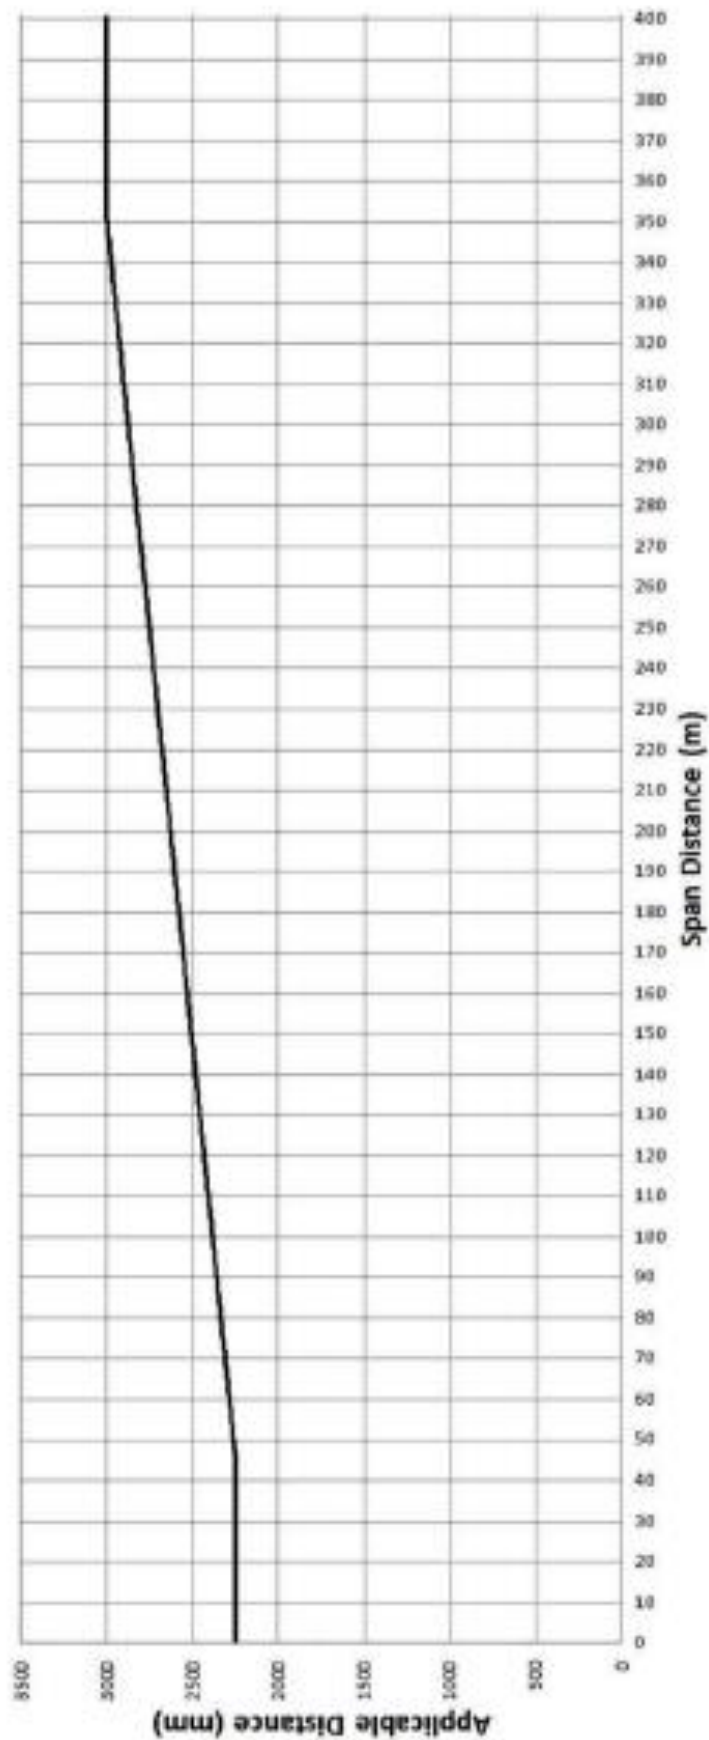
GRAPH 6—UNINSULATED 66 000 VOLT ELECTRIC LINE IN HAZARDOUS BUSHFIRE RISK AREA

Clauses 3 and 29

Graph 6 Formula

The formula by which the applicable distance for the middle two thirds of a span of an electric line to which clause 29 applies is calculated is as follows:

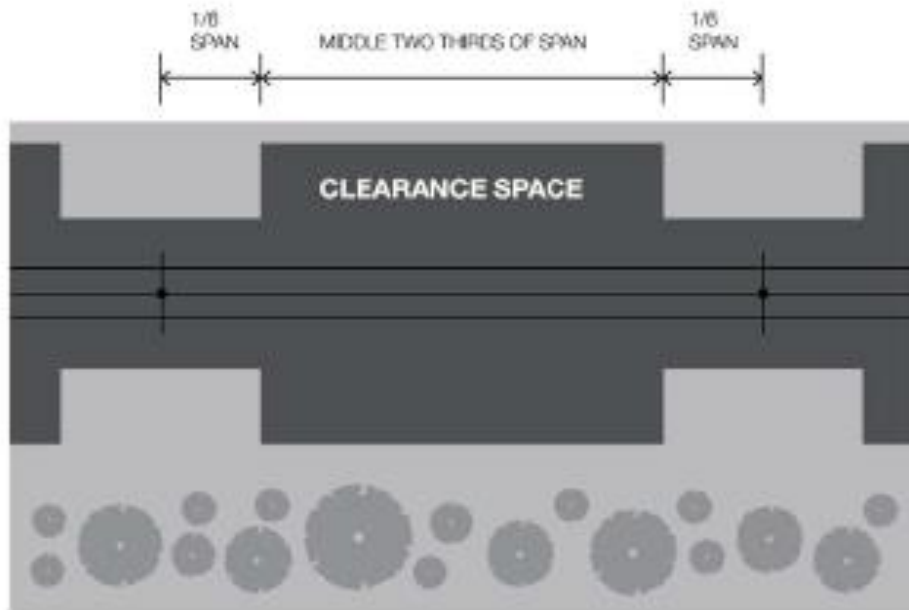
FIGURE 1—PLAN VIEW OF ELECTRIC LINES IN ALL AREAS

Clauses 24, 25, 26, 27, 28 and 29,
Graphs 1, 2, 3, 4, 5 and 6

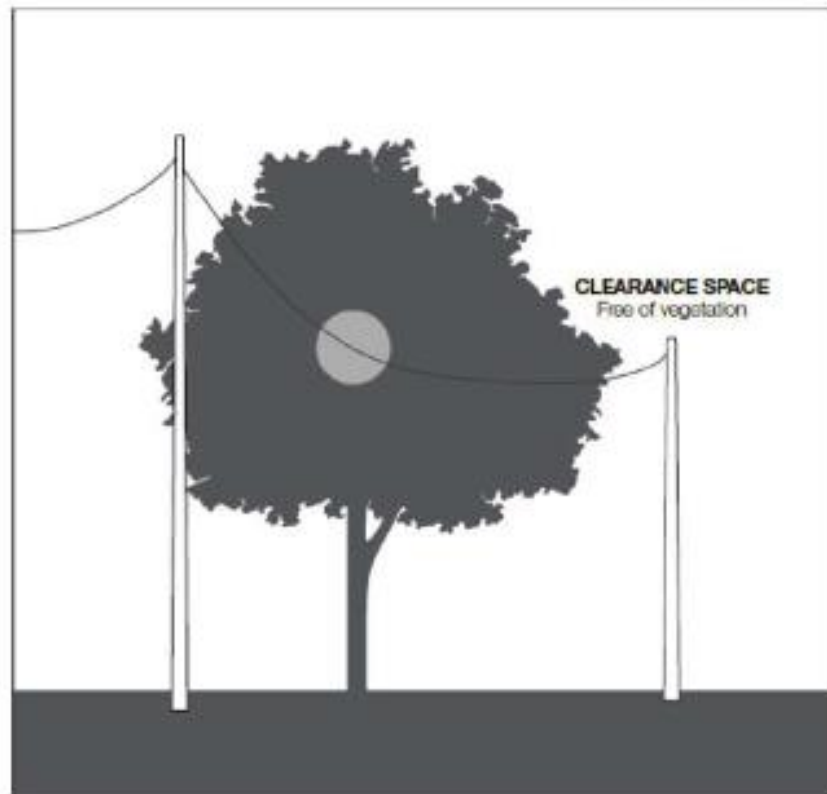
FIGURE 2—INSULATED ELECTRIC LINES IN ALL AREAS

Clause 24, Graph 1

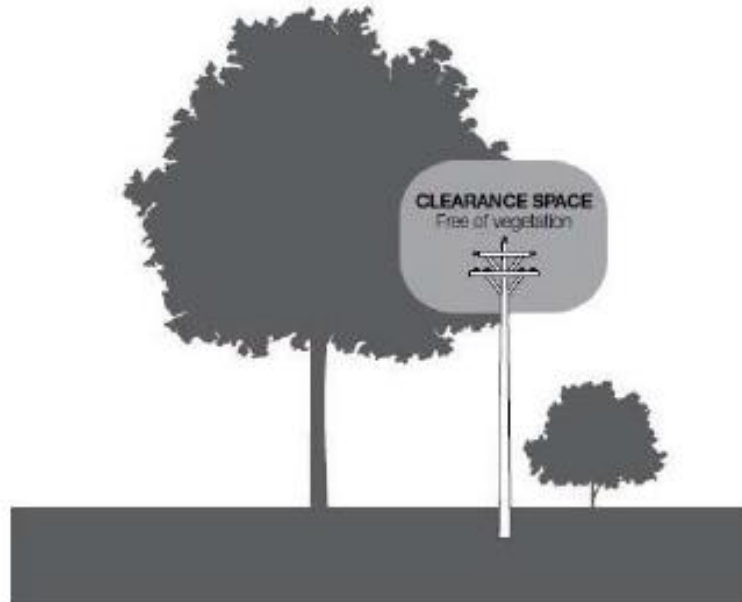
FIGURE 3—INSULATED ELECTRIC LINES IN ALL AREAS AND UNINSULATED HIGH VOLTAGE ELECTRIC LINES (OTHER THAN 66 000 VOLT ELECTRIC LINES) IN LOW BUSHFIRE RISK AREAS

Clauses 24 and 26, Graphs 1 and 3

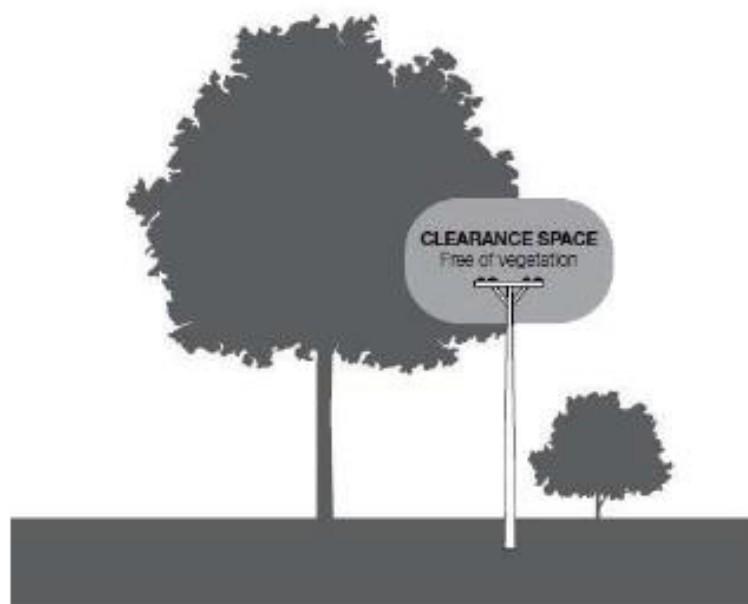
FIGURE 4—UNINSULATED LOW VOLTAGE ELECTRIC LINE IN A LOW BUSHFIRE RISK AREA

Clause 25, Graph 2

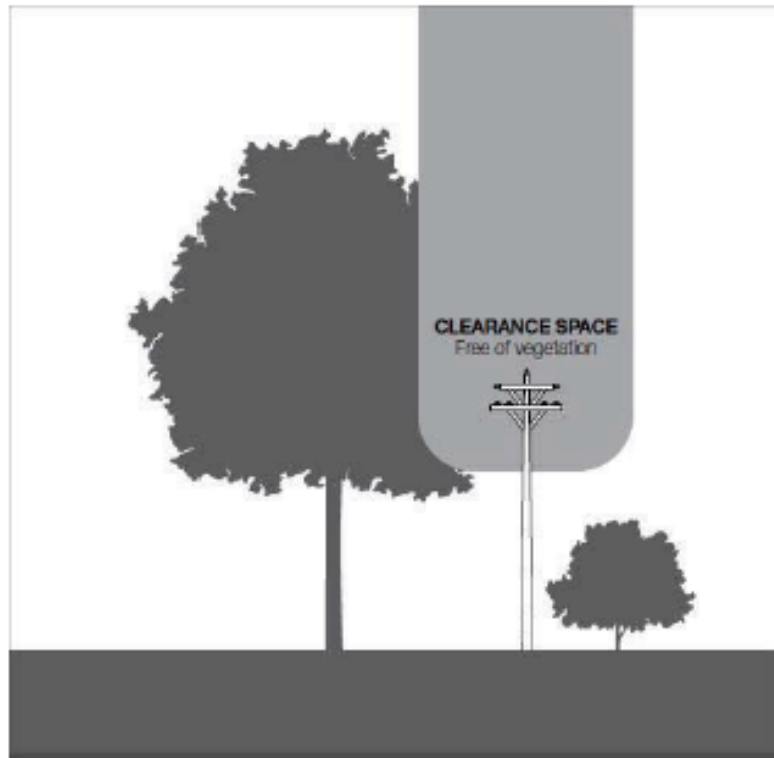
**FIGURE 5—UNINSULATED 66 000 VOLT ELECTRIC LINE
IN A LOW BUSHFIRE RISK AREA AND UNINSULATED
ELECTRIC LINE IN A HAZARDOUS BUSHFIRE RISK AREA**

Clauses 27, 28 and 29, Graphs 4, 5 and 6
